# **TellerScan™ 240**

## **Countertop Check Scanner**

# **Service Manual**

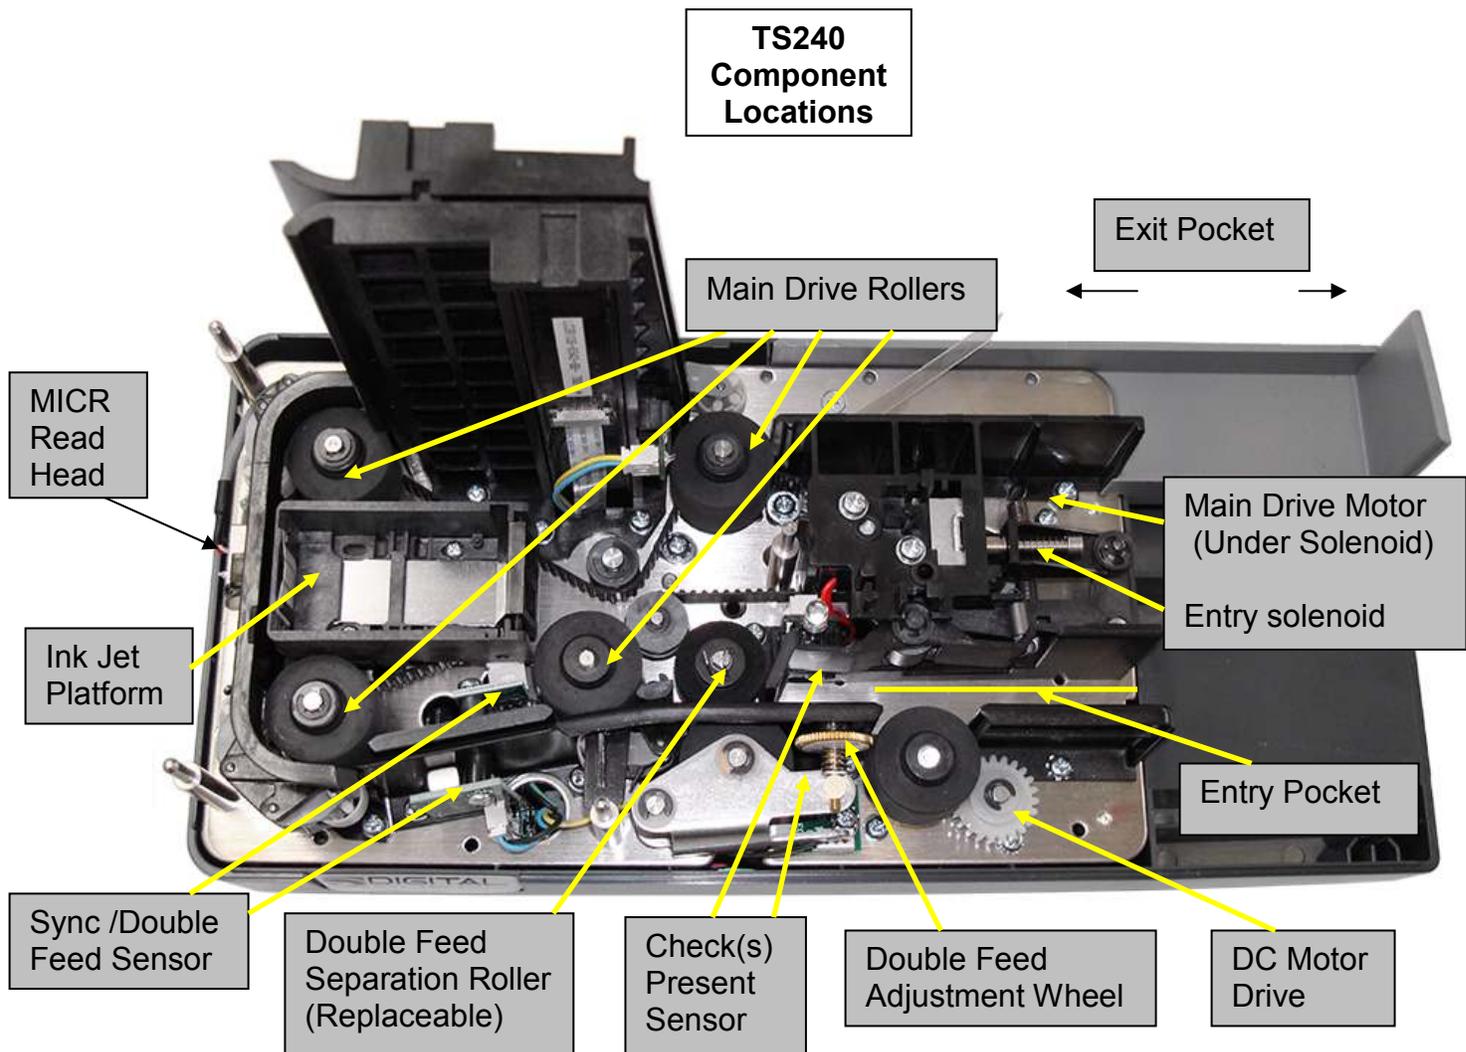
The presence of checks at the feeder entrance is detected by an infrared (IR) sensor placed just slightly above the surface of the Base Plate. This placement is intended to insure that checks are positioned all the way down flat against the base plate prior to pulling them into the scanner track (see illustration below).

On the TS240 the Check Present sensor is comprised of an IR LED (D2) which is located on the outboard side PCBA (P/N 913022). This device is multiplexed with a secondary VBUS monitoring function so its drive is a rectangular waveform designed to minimize the aging effect of driving the device continually. The associated IR Photo-Detector (Q2) is located on the inboard side PCBA (P/N 153120-01). When this sensor is interrupted, a signal is sent to the Main PCBA and the LED Status Indicator is illuminated Amber.

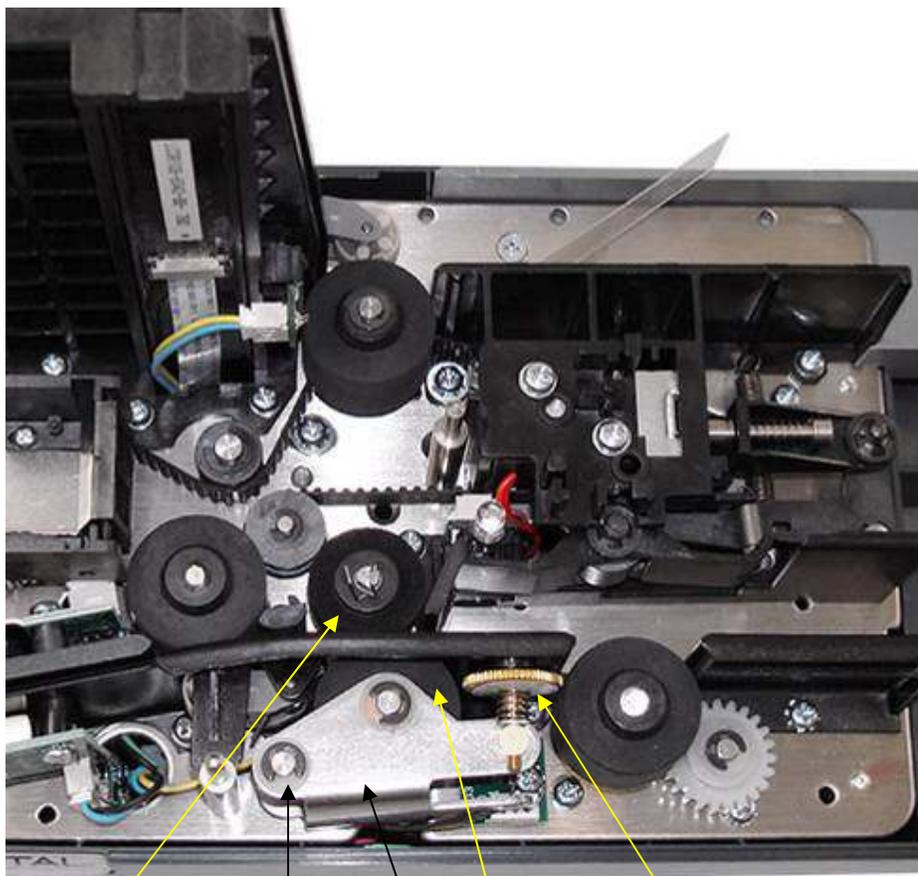
Scanners with automatic document feeders (ADF) that have the ability to strip checks from a stack must have a means to prevent multiple checks from entering the scanner simultaneously. This is the function of the discriminator roller assembly. The assembly consists of a Dense Foam roller that is stationary during the feed cycle, but indexes backwards 1/8 turn at the end of each cycle (and during scanner initialization) in order to distribute the wear evenly around the periphery of the roller. A Solid Rubber Drive Roller that turns forward is housed in a spring-loaded Sheet Metal Bracket that pivots about a pin. The Sheet Metal Bracket position is adjusted at the plant and should not need adjustment in the field for the next 100,000 items. It's adjusted by means of a small Thumbwheel located at the top of the bracket (see illustration below).

Dense Foam Roller  
 Pivot Pin  
 Sheet Metal Bracket  
 Solid Rubber Drive Roller  
 Factory Adjust Thumbwheel

The stationary dense foam roller holds back all but the first check in the stack, while the forward turning of the solid Drive Roller strips the first check from the stack and passes it on to the first set of pinch rollers.

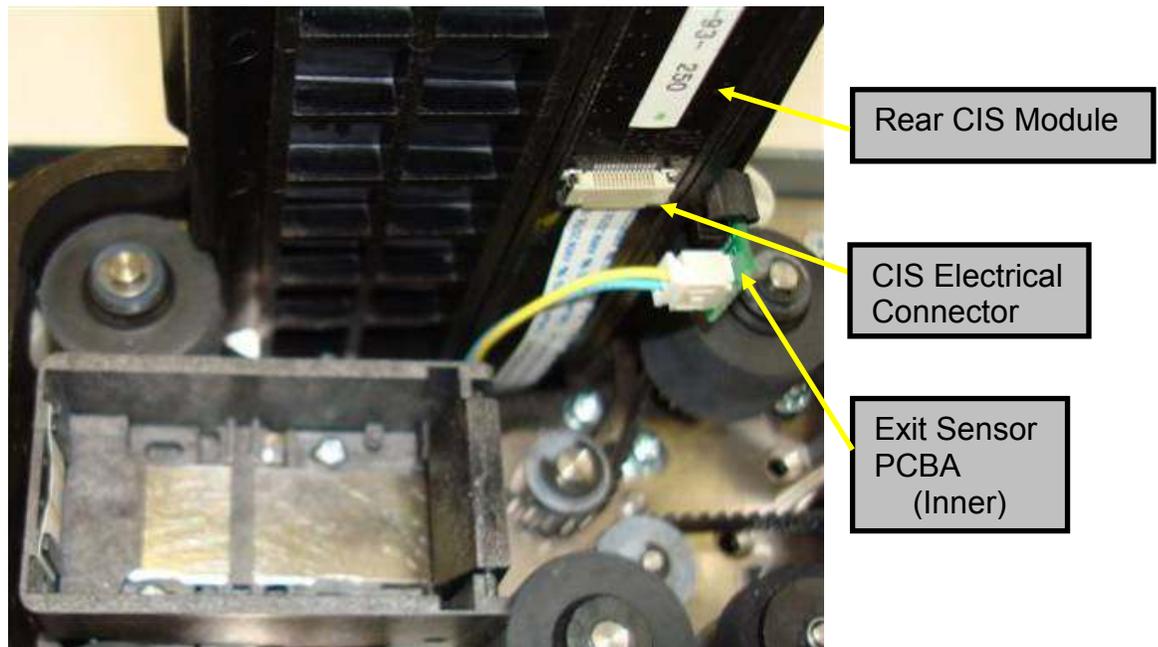
The TellerScan™ 240 Scanner utilizes the latest Contact Image Sensor (CIS) technology to acquire the raw check images. CIS modules are complete self contained assemblies comprising the LED light source, optical Selfoc (rod) lens, photo-diode receptors, and signal amplifier all mounted to a ceramic substrate. These components are housed in a molded plastic module and operate from a single voltage power supply (see illustration below). The module has a polished glass faceplate on the viewing side. In practice, the document to be scanned is passed by the glass faceplate while the CIS module illuminates and captures the data at optimum focus producing the highest quality image definition and contrast.

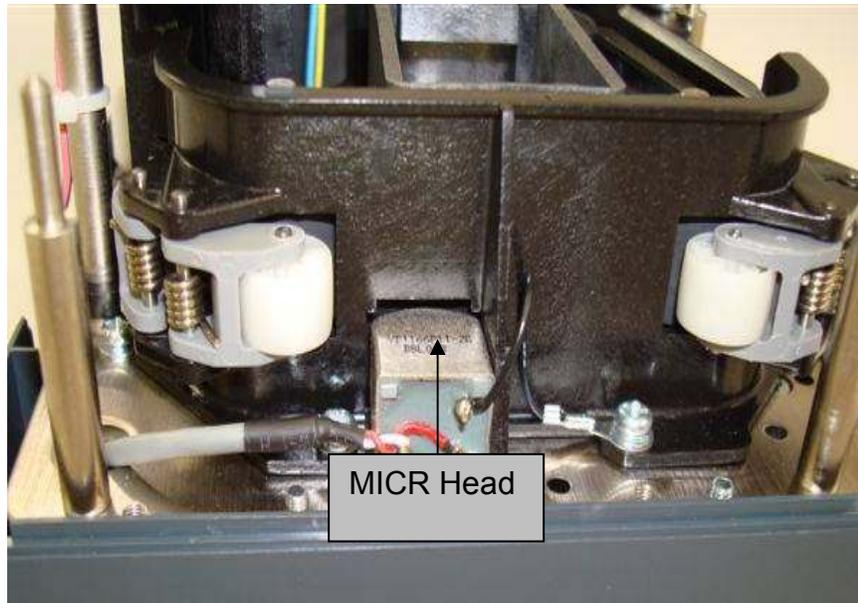
The analog head registers the variations of magnetic flux caused by the passage of the magnetic characters against the physical head. The check is held against the head in the area of the MICR code line by means of a spring loaded small plastic roller assembly. The check passes the head at a constant linear speed of 50 cm/sec. The magnetic ink on the check is first polarized by the permanent magnet located immediately before the MICR Head. See location of the MICR head in the pictorial below.

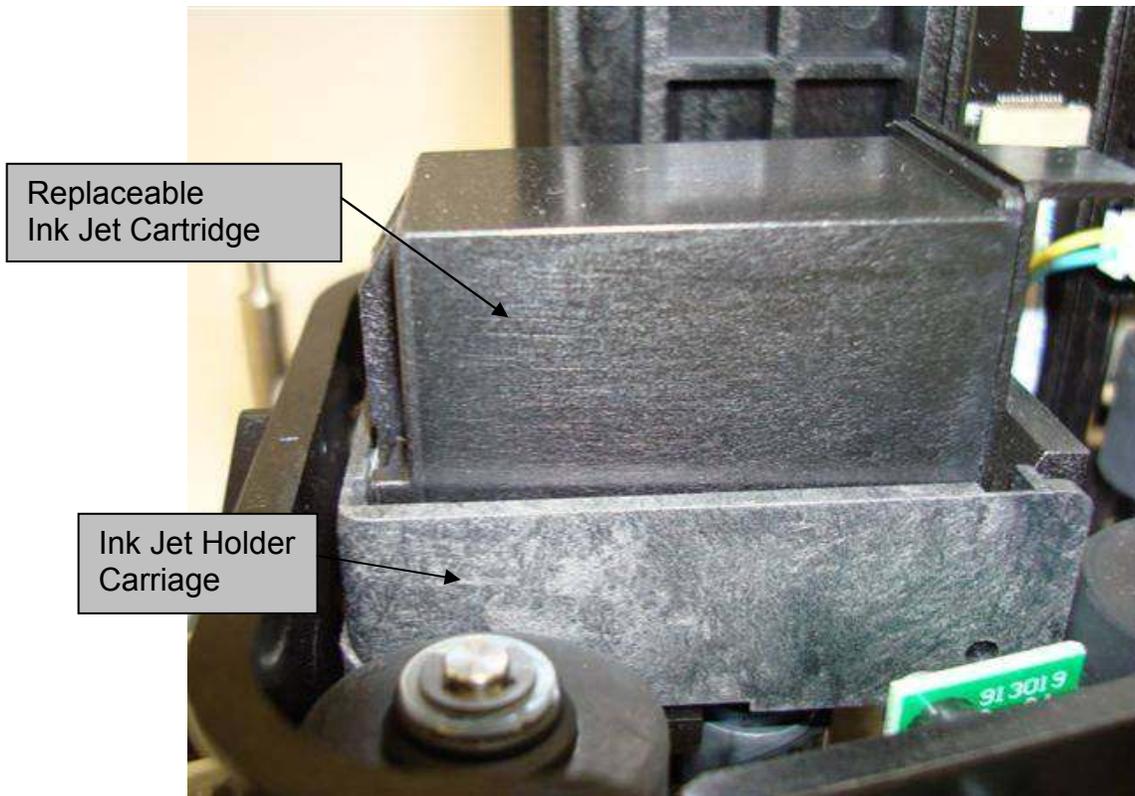
The print endorsement on the back of the check is made using Hewlett Packard ink jet technology. The HP c6602a inkjet printer cartridge was selected because of its small size, relatively low cost, fast drying ink, and large reservoir capacity. The cartridge is available in black, red, green or blue colors, and prints up to 7,000,000 characters from a single cartridge. This cartridge has 12 nozzles and produces a good quality print with only a single pass while the check is being transported for scanning. The cartridge has an easy snap-in feature to facilitate replacement by the scanner operator (see illustration below).

The inkjet holder carriage assembly is set at a fixed height and is not adjustable.

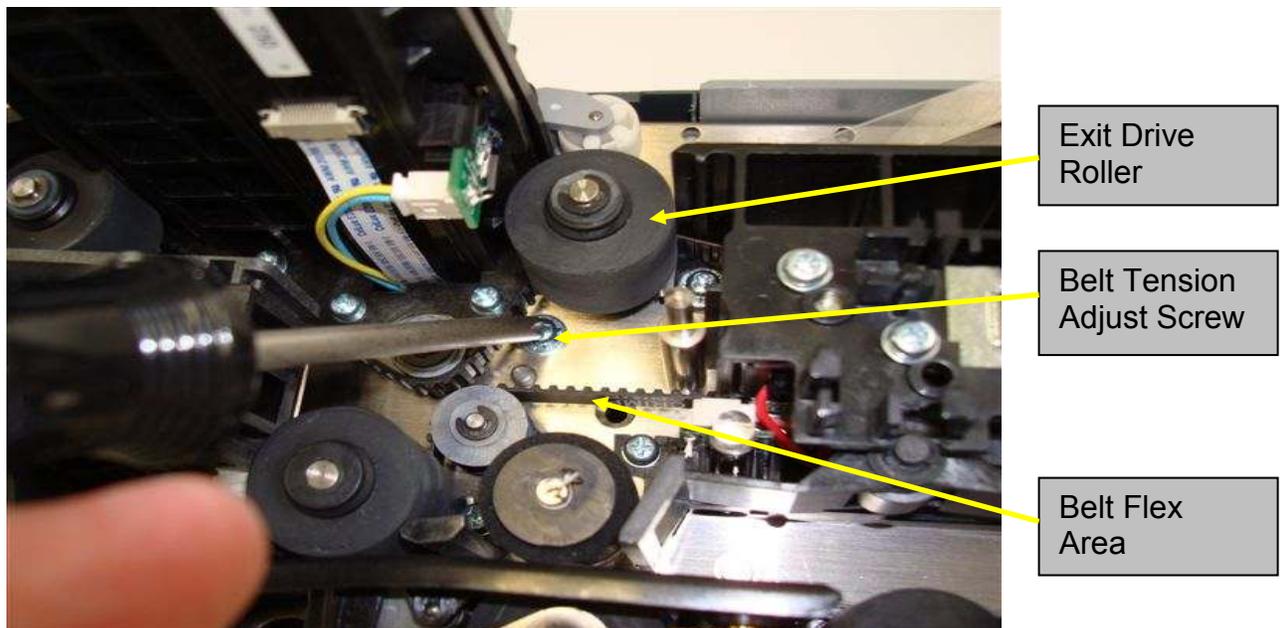
Proper belt tension is defined as that tension that allows the belt to just have a little flex when pressed in the area indicated, but when manually turning the Exit Drive Roller both clockwise and counter clockwise fairly rapidly, the belt will not jump or skip teeth positions.

The adjustment is made with the Belt Tension Adjustment screw (see illustration above).

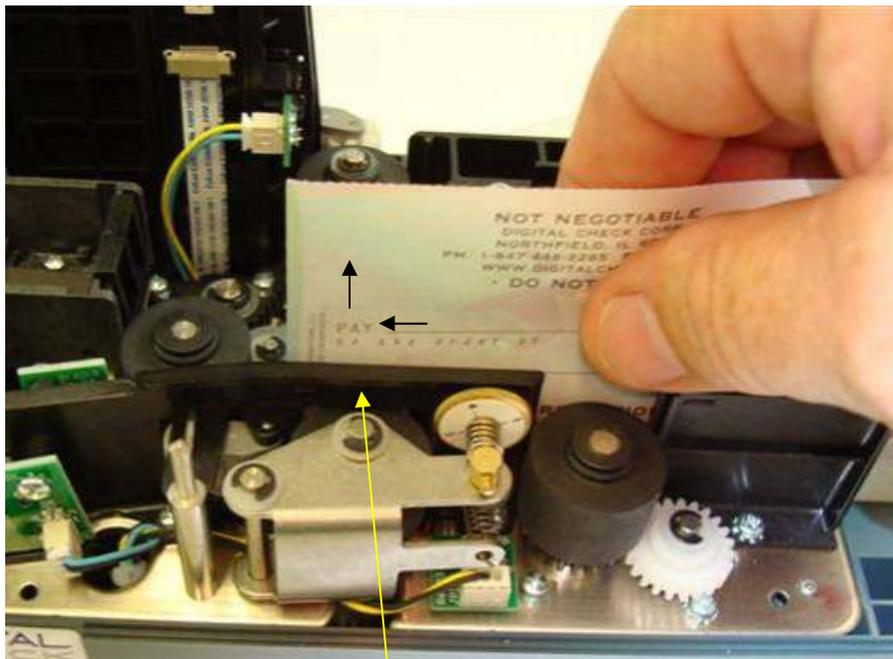
The adjustment is set at the factory and normally does not need further adjustment in the field until after 100,000 items have been run through the unit. A good starting point for the adjustment is when the friction between the two rollers allows for a single document to be slide between them and pulled up vertically feeling a modest amount of resistance.

Slide a document between the pinch of the two rollers then slowly lift vertically until the document clears the rollers to get a better feel. A modest amount of drag should be felt.

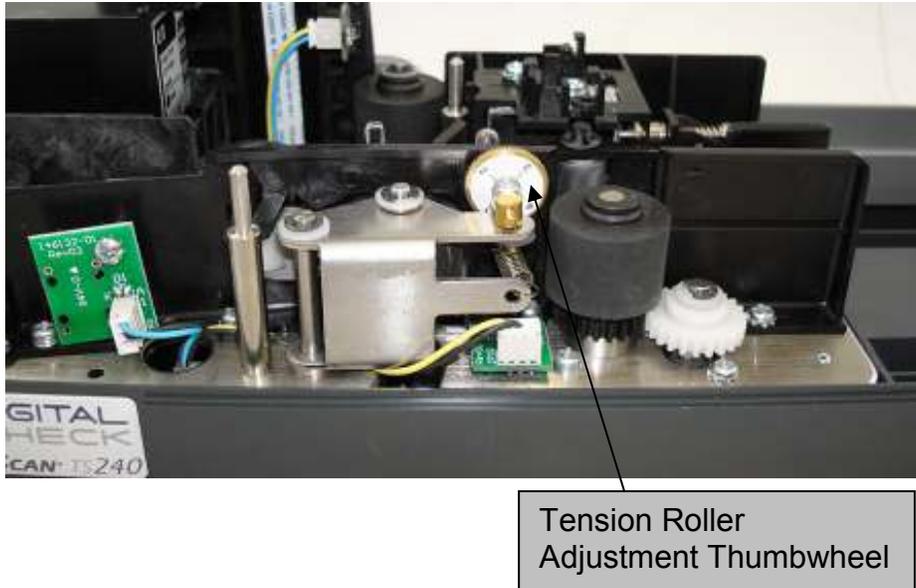
If you are experiencing chronic double feeding of documents, turn the Adjustment Thumbwheel 1/4 turn counter clockwise (CCW) and retest (see illustration below). Adjustments should be made only in 1/4 turn increments and always retest. Remember CCW tightens the pinch between the 2 rollers, and CW loosens the pinch.

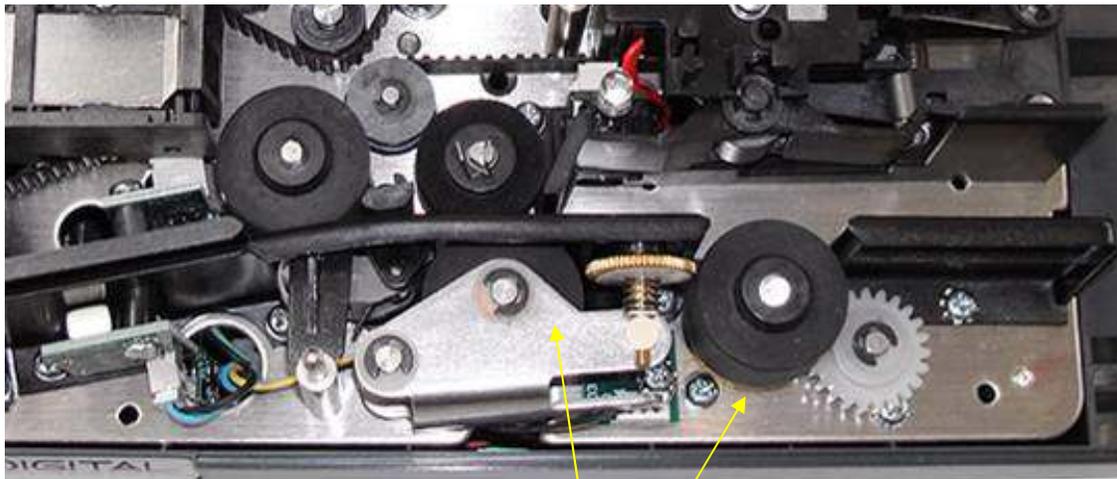
- a. Carefully tear open the end of the foil pouch so as not to damage the card, then remove the card from the pouch.
- b. To clean the Input Drive Rollers (as illustrated below), insert the TellerScan Cleaning Card into the hopper entrance so the leading edge is fully inserted into the entry pocket. While firmly holding on to the end of the card, command a scan cycle and allow the first two sets of rollers to turn against the card to clean themselves. Gently pulling back on the card while the roller is turning will facilitate the cleaning process.
- c. Repeat the process two or three times using a different part of the card.

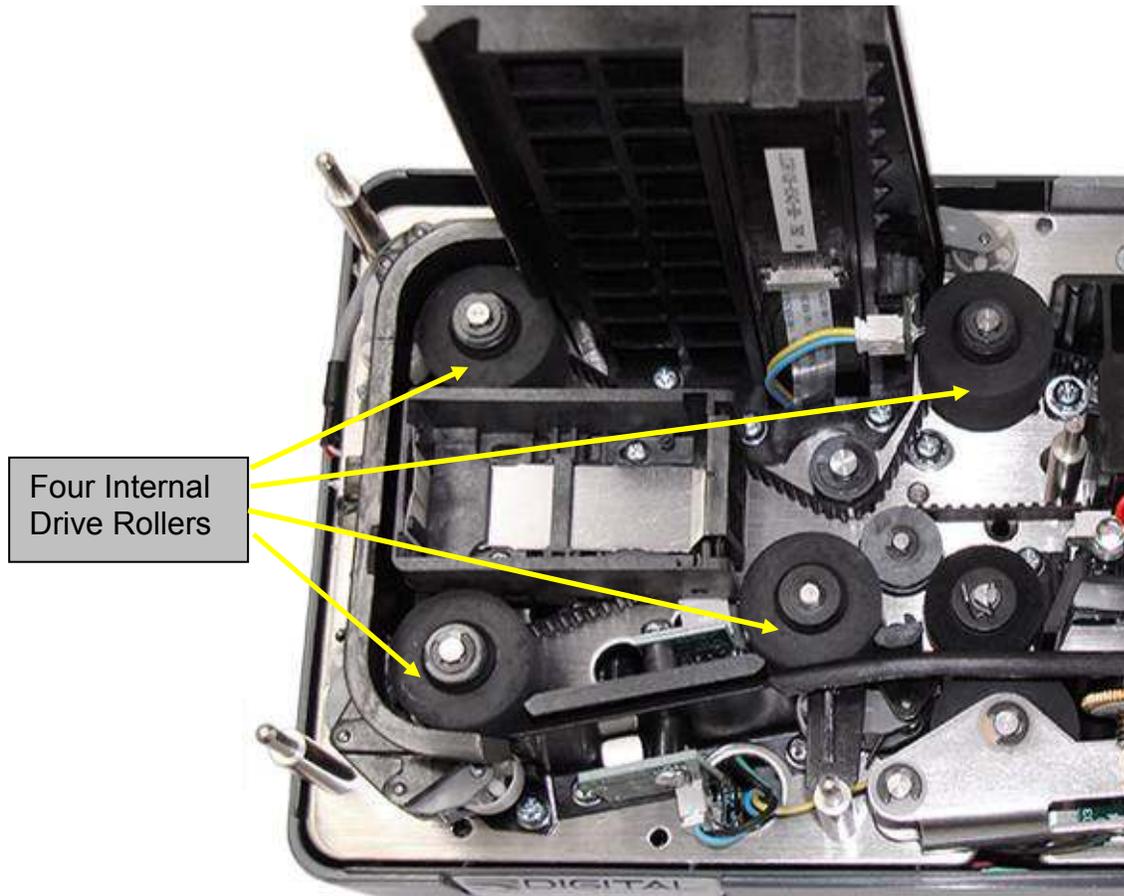
- a. To clean the four (4) internal drive rollers (illustrated below), use the Cleaning Swabs (P/N IS0030) that come in the cleaning kit and carefully hold against the side of one of the internal drive rollers. Using the ScanLite Program, command an Eject cycle and allow the rollers to slowly turn against the swab.
- b. Repeat the process with each of the remaining internal drive rollers.

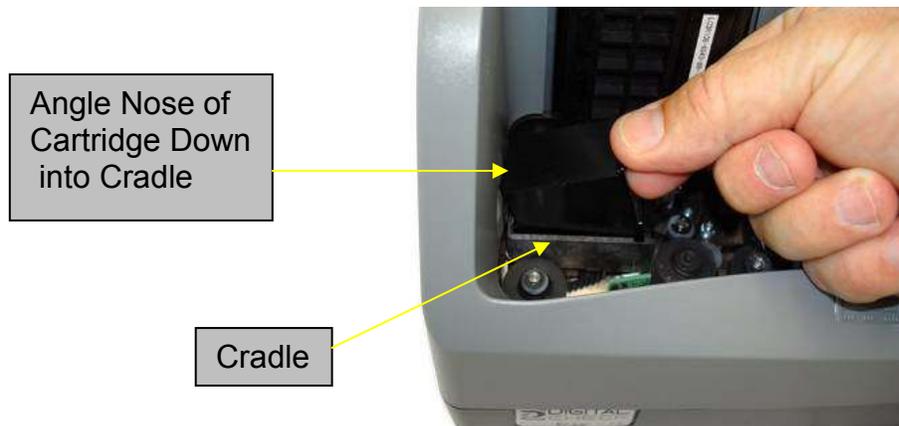
- e. Insert the nose (ink-jet end) of the cartridge into the cradle in the scanner (as illustrated below) then slide forward while keeping the reservoir end of the cartridge tilted slightly upward.
- f. Push the cartridge downward firmly until it snaps into position.
- g. Replace the Center Cover.

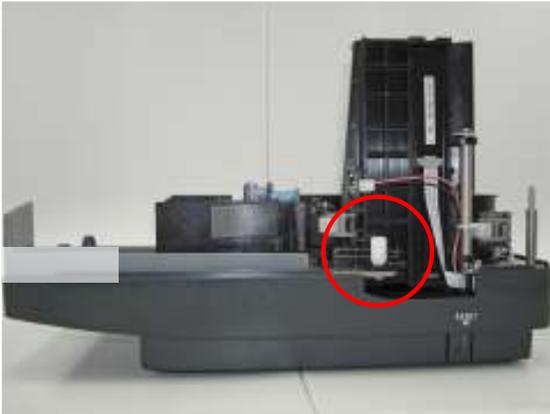
**Step 1:** Remove the Center and Outer scanner covers. Locate and remove the White Nylon Thumbscrew.

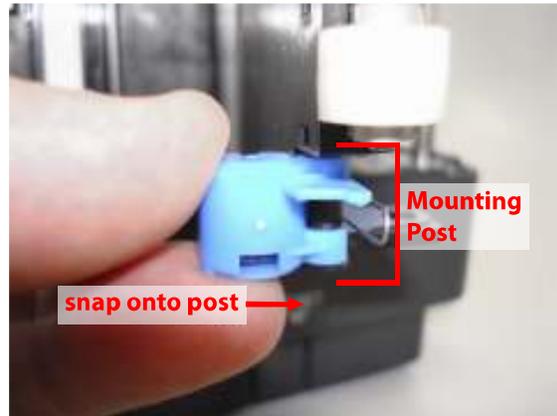
**Step 2:** Swing out the outer Camera Door. Locate the Franker Roller Mounting Post.

Hold the Franker Roller with the tab facing out and lined up with the Metal Spring. Snap the Franker Roller onto the Mounting Post.

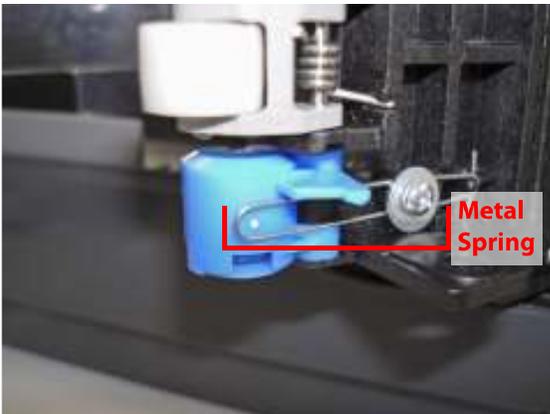
**Step 3:** Rotate the Franker Roller until it touches the Metal Spring (as shown).

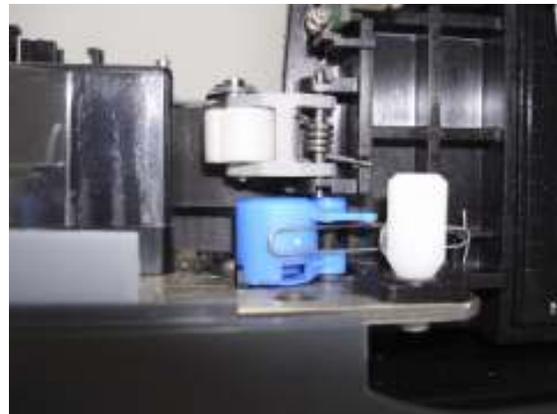
**Step 4:** Close the Camera Door and screw the White Nylon Thumbscrew back in place.

Replace the Center and Outer scanner covers.

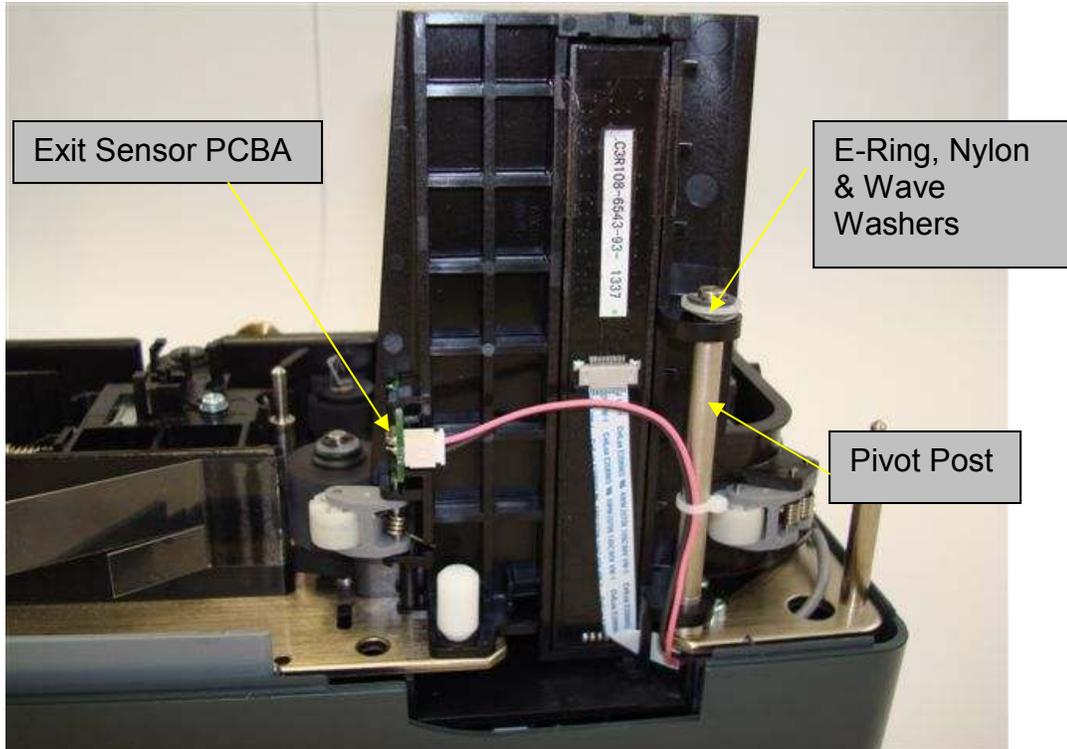
To remove the outboard module assembly from the scanner, first unplug the cable to the Exit Sensor PCBA, then unplug the FFC ribbon cable at the main circuit board connector J1 (see connector location illustration in Section 8 of this manual). Remove the e-ring and associated nylon washer and wave washer securing the holder to the top of the vertical pivot post at the rear side of the assembly (as illustrated below). Remove the thumbscrew, then lift the assembly off the post. During reassembly, the nylon washer must go against the e-ring with the wave washer underneath the nylon washer.

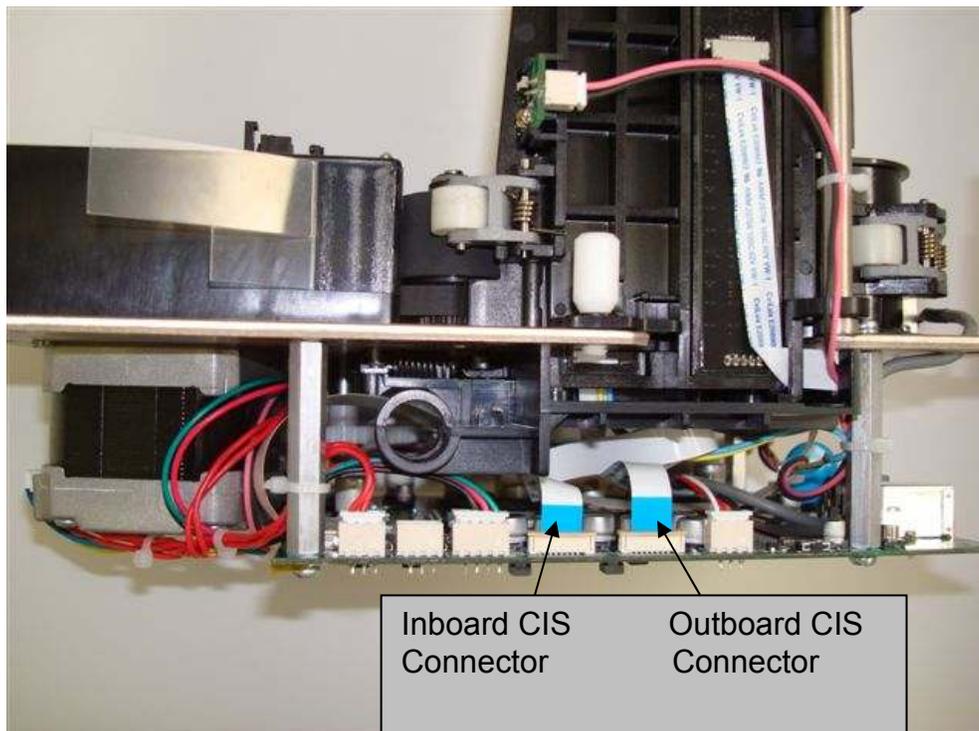
NOTE: When replacing the CIS modules be certain to plug the correct CIS into the correct connector on the main circuit board, otherwise the front and rear images will be reversed. For reference purposes, the inboard CIS plugs to the outside connector near to the edge of the board (as illustrated below).

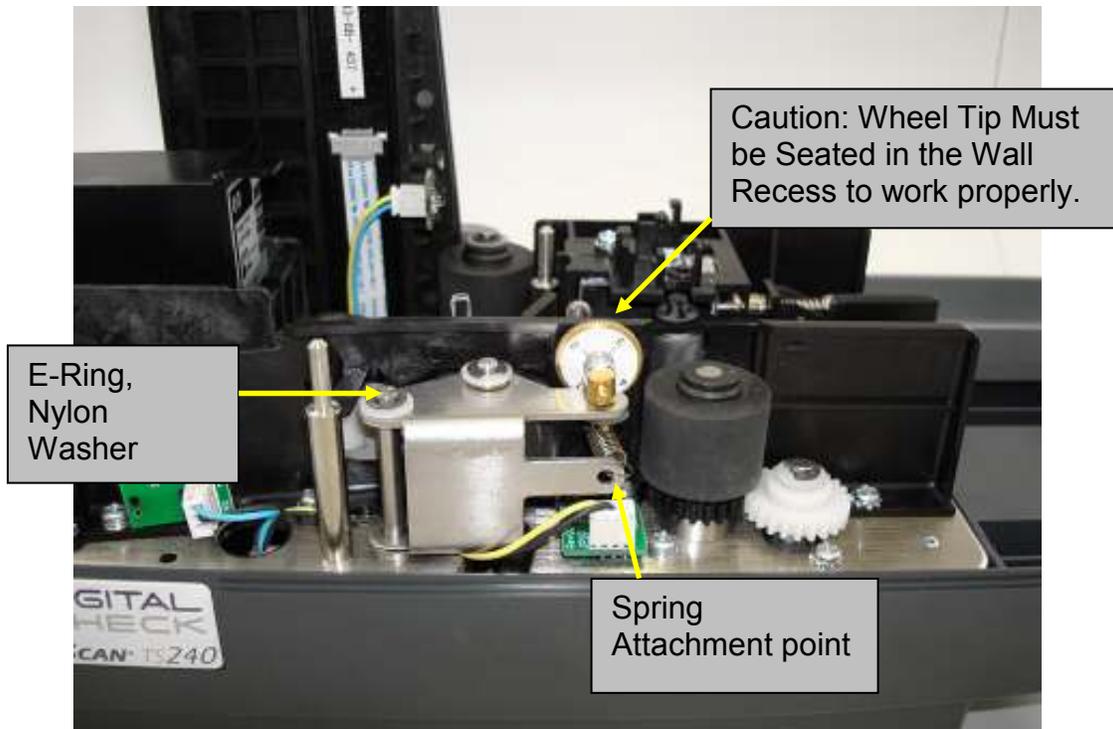
Remove the separator roller assembly by first separating the spring from the hole in the end of the sheet metal bracket (as illustrated below).

**CAUTION:** When re-installing the spring, insure that the pin tip on the far side of the brass thumbwheel engages into the mating hole in the plastic side wall as shown above.

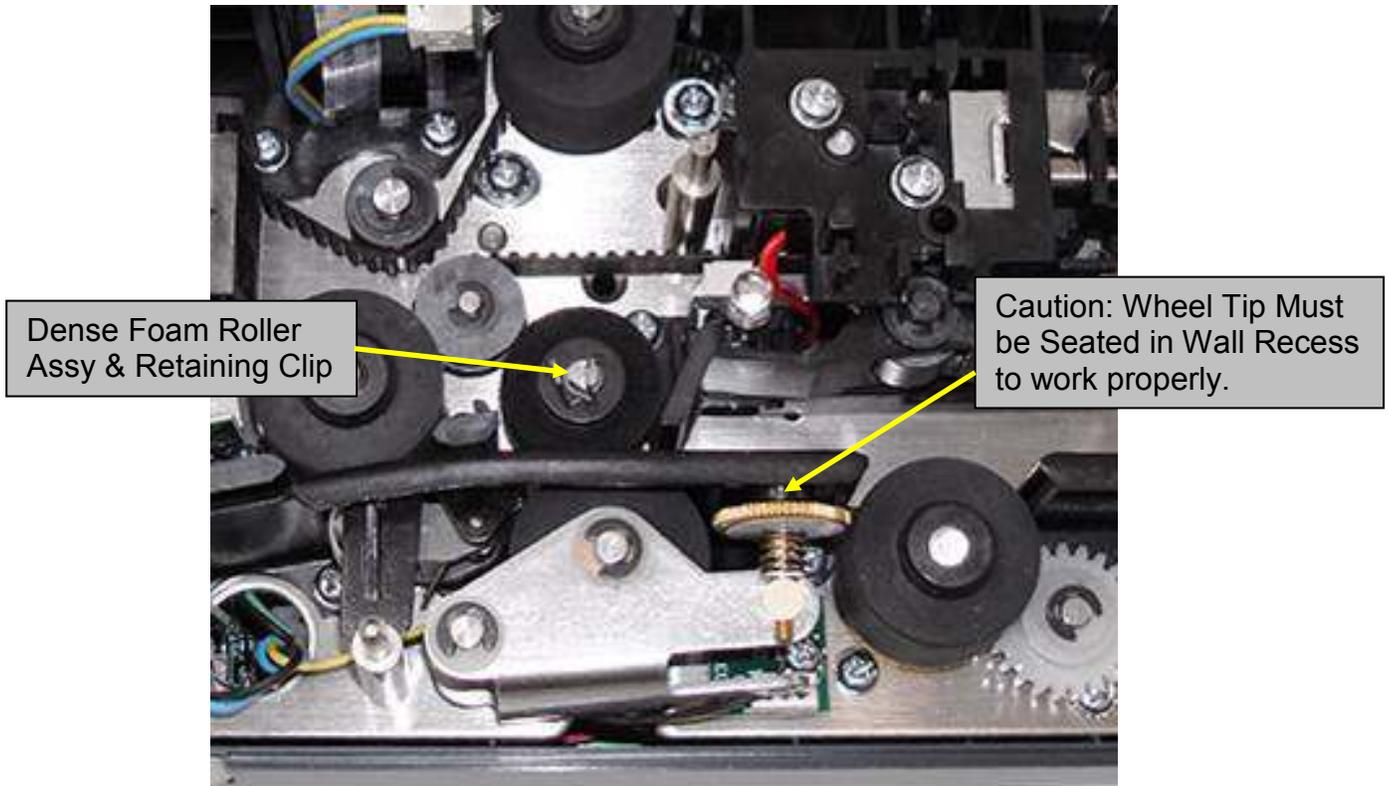
**CAUTION:** When replacing the Dense Foam Roller, the height on the Drive Shaft is important. Align the top edge of the foam roller with the top edge of the outer rubber roller by making sure the hub is fully seated. This is a 'D' shaped shaft. (see illustration below).

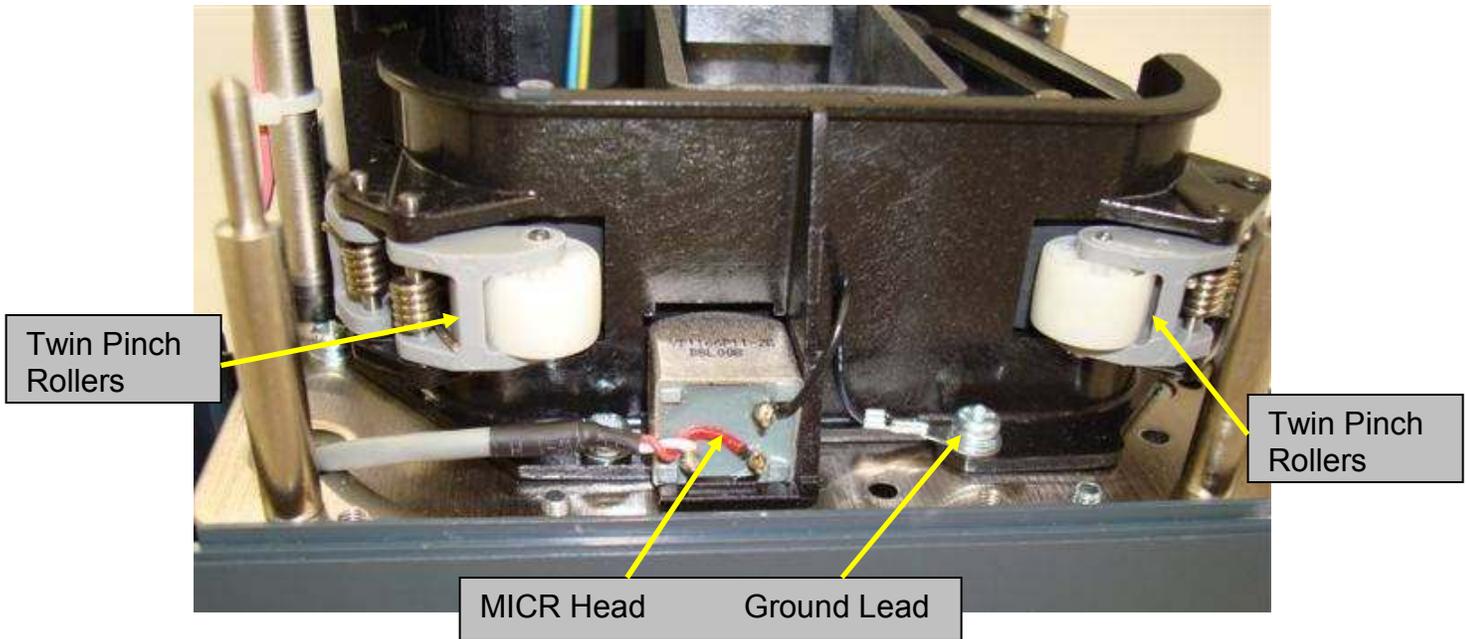
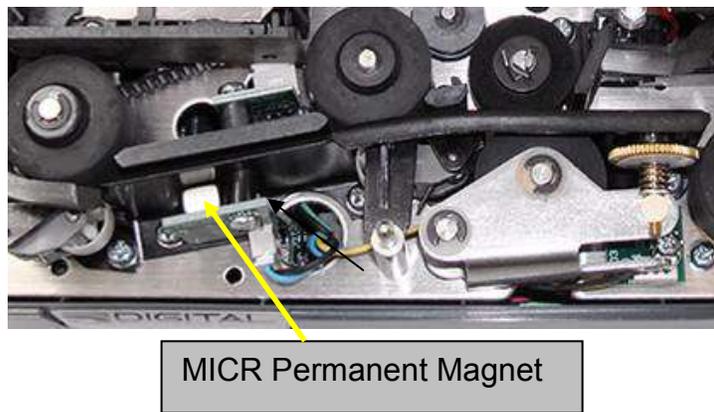
The MICR curve assembly consists of the MICR head, together with two sets of twin pinch roller assemblies, one at each 90 degree corner. (See illustration below). The pinch rollers are spring loaded against the mating Internal Drive Rollers when the entire assembly is fastened into its normal mounting position on the baseplate.

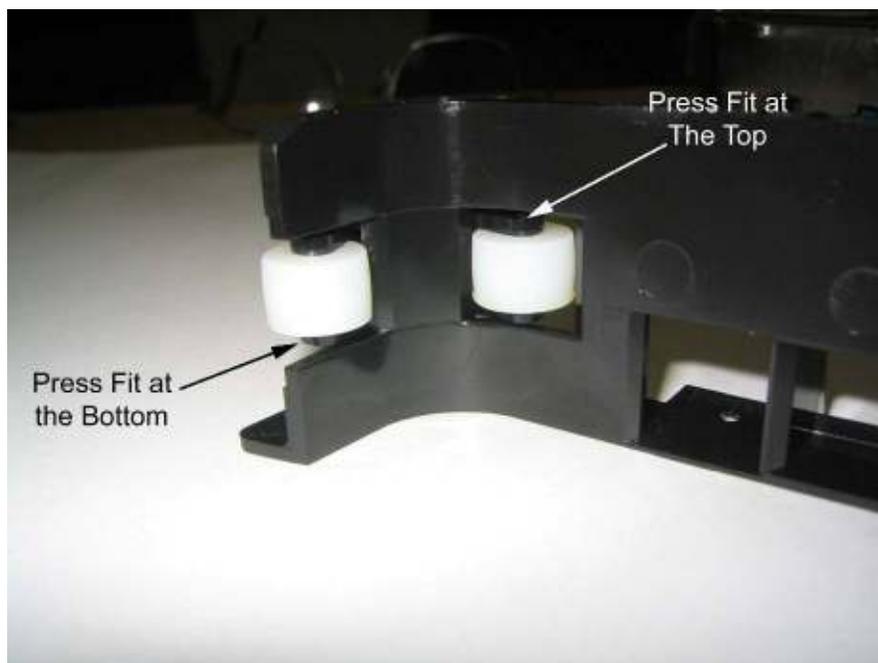
Standard (5) idler assemblies (PN 921091)

Slotted exit idler assembly (PN 921091-01)

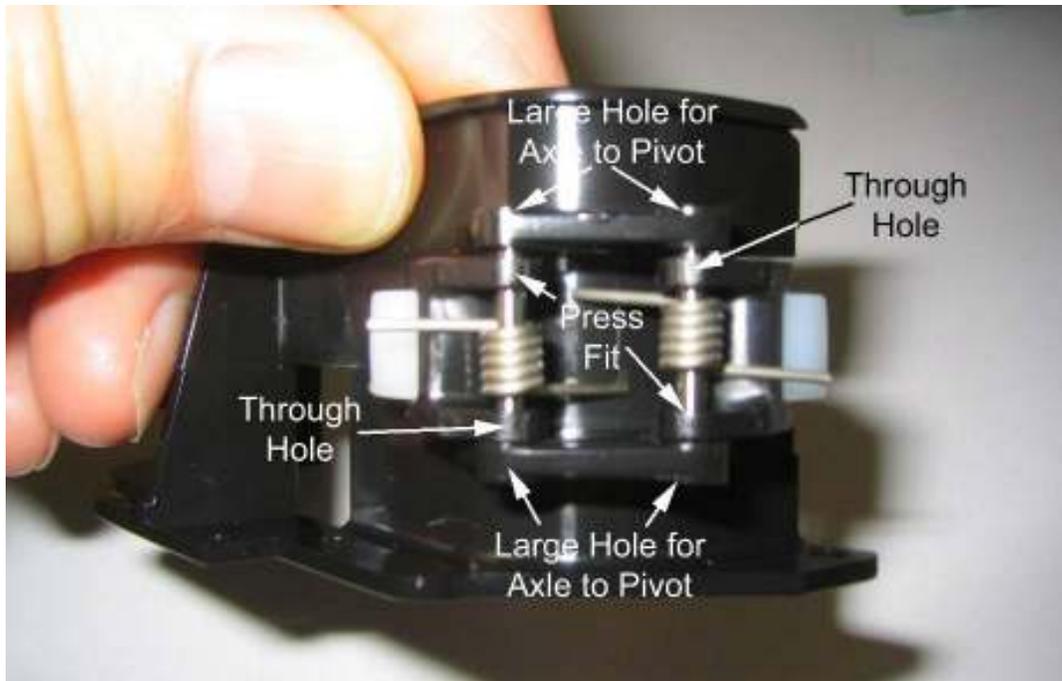
The Shafts that pass through the center of the Springs use the same attachment concept, however, in this case, the axle pivots at both ends in the through holes of the plastic curve, and is held in place by means of a press fit in one of the H bracket holes. Again, normal assembly is the shaft is first passed through the large hole in the plastic Curve, then through the large hole in the H Bracket, then through the Spring, then pressed into the small hole in the H Bracket, and finally through the large hole in the other end of the plastic curve (as illustrated below).

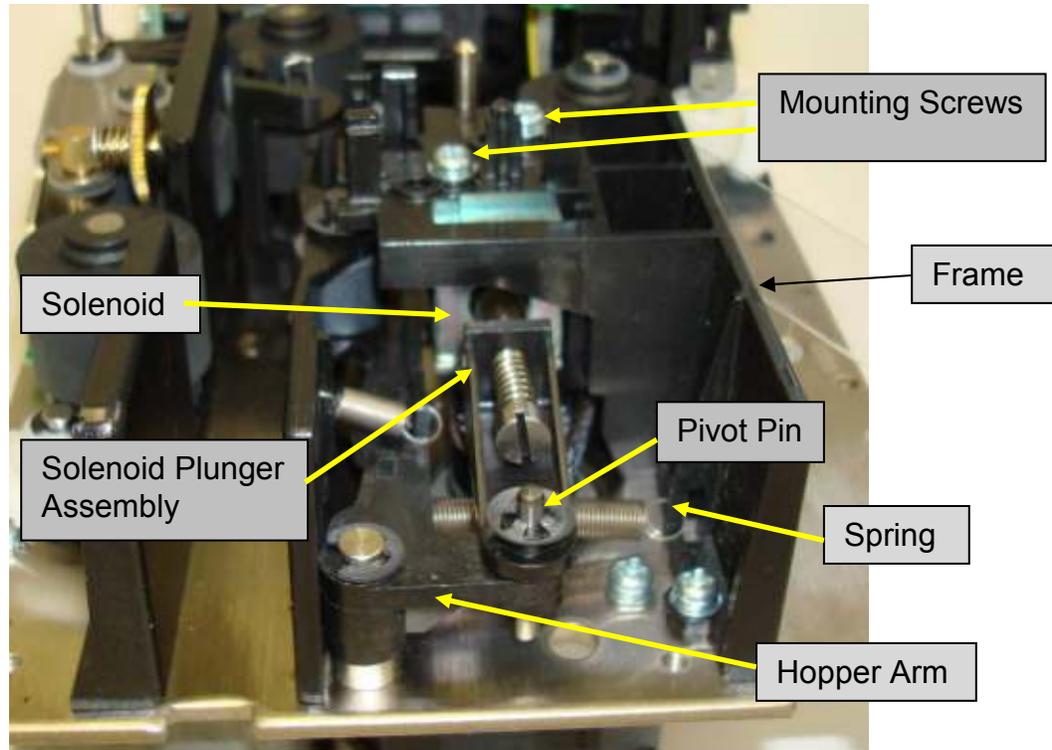
## 6.8 Solenoid

Gently detach the rear end of the Spring from the Frame as illustrated below being careful not to damage the Spring.

Remove the three (3) screws securing the Frame to the base plate, then lift the entire assembly out.

Remove the two (2) Mounting Screws securing the Solenoid to the Frame.

NOTE: When replacing the assembly, the position of the solenoid frame must be such that the plunger (once the linkage is installed) easily moves in and out of the solenoid cavity. The holes in the solenoid bracket, where it attaches to the base plate, are large enough to provide adequate movement to allow proper alignment of the of the solenoid bracket to the movement of the plunger. Be certain the plunger moves freely throughout the entire stroke and does not rub against the sides of the solenoid cavity. When properly aligned, the plunger will go straight down the center of the cavity. The linkage mechanism should be totally free to move when actuated manually.

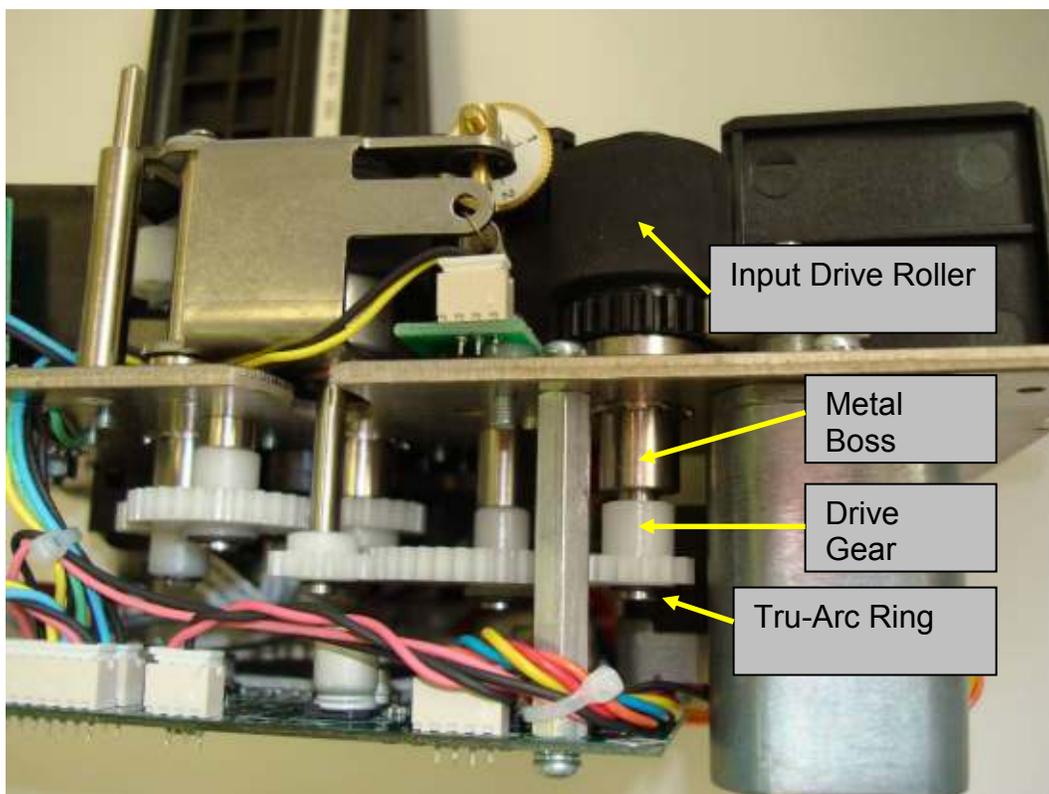
## 6.10 Input Drive Roller

The Input Drive Roller is a bushing style assembly with a gear pressed on (slip fit) to the bottom of the roller shaft (see illustration below).

To remove the roller, remove the Tru-Arc ring from the end of the Drive Shaft. Next, insert the blade of a flat screw driver between the top of the plastic gear and the metal boss protruding down from the underside of the base plate. Rotate the screw driver gently to pry the gear down the shaft. Grasp the gear firmly, then pull off the end of the shaft. The roller can now be removed from the top side of the base unit.

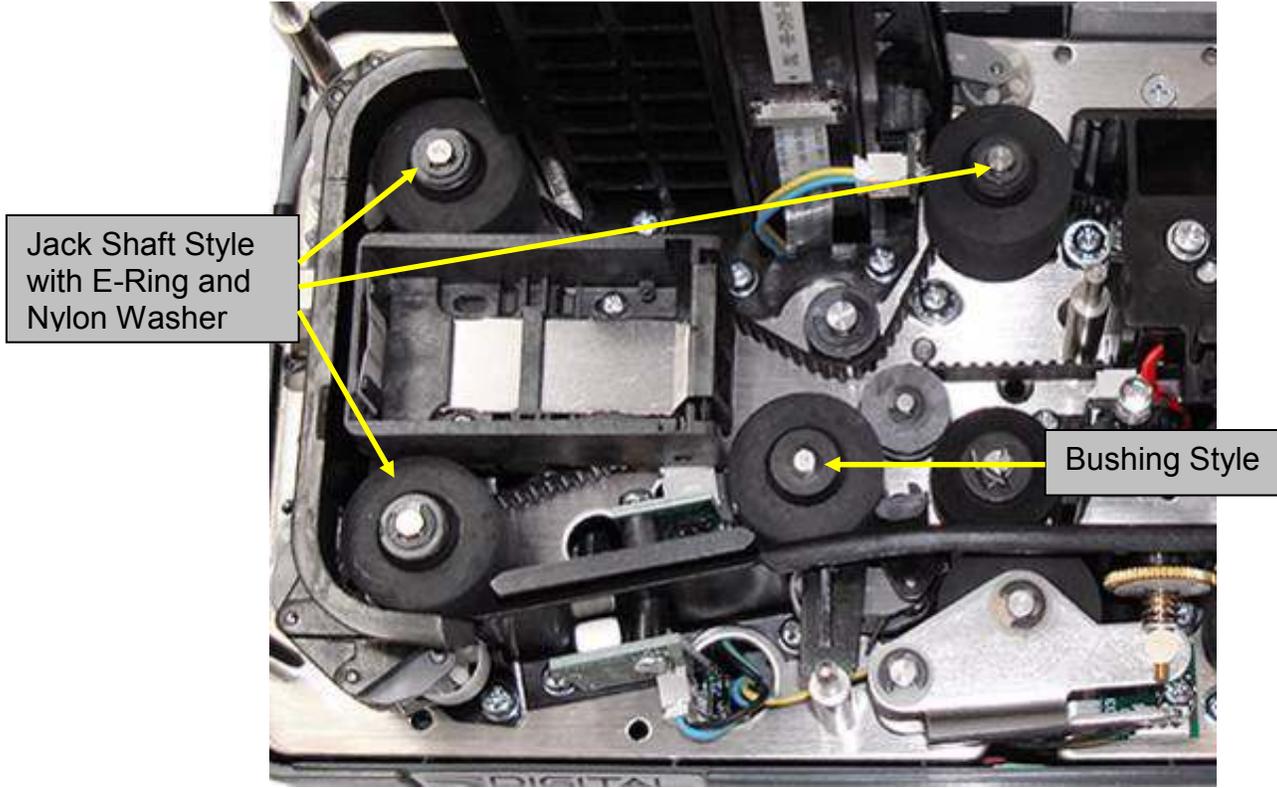
## 6.11 Internal Drive Roller Assemblies

There are four (4) Internal Drive Roller Assemblies, three (3) of the jack shaft style, and one (1) with a Bushing that allows the shaft to protrude below the base plate where a drive gear is

mounted (see illustration below).

In order to remove the last two (proceeding around the track in a clockwise fashion) Internal Drive Roller Assemblies, it will be necessary to first remove the inboard CIS Module as previously described in this section of the manual.

To remove the jack shaft style assemblies, simply remove the e-ring and associated nylon washer from the top of the shaft, then rotate the roller while lifting the roller off the shaft end.

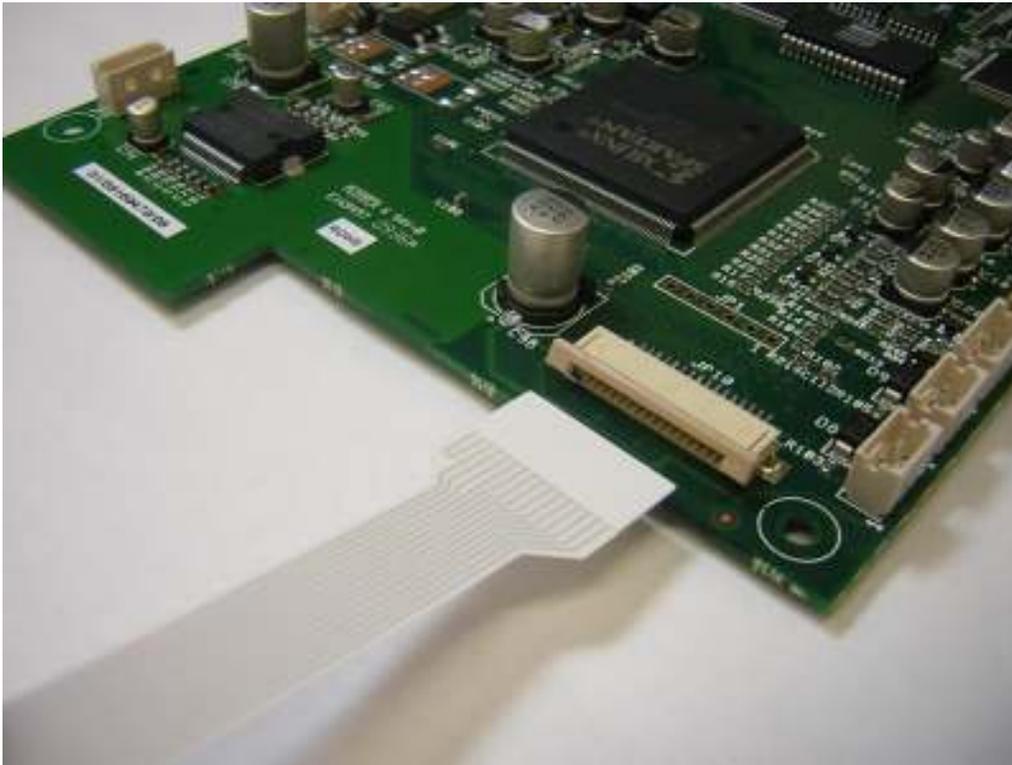
Unplug the six (6) connectors along the front side of the circuit board, then the six (6) connectors along the back side while the board is still mechanically secured. Remove the four (4) screws securing the board to the standoffs. Gently slide the board straight down, then carefully unplug the inkjet ribbon cable from the main board at position JP10.

**CAUTION:** The Printer ribbon cable and associated connector are very fragile. Exercise patience and a gentle touch when working with this connector so as not to cause any damage which could render your main board useless. To unplug the ribbon cable from the connector, very gently pull back the connector plastic lock evenly on both sides with your finger nails. Once open, the cable will easily pull out. When re-installing, slide the cable squarely into the socket (noting the orientation of the electrical contacts), then push the connector plastic lock evenly on both sides to hold the cable in place. Gently pull on the ribbon cable to insure it is locked into the connector securely. See illustration below for proper (electrical contacts of pins facing down) cable orientation.

**CAUTION:** Whenever re-installing the PCBA mounting hardware, insure that the proper washers are installed in the proper positions so as to insure grounding through the metal support studs. Note that the pad on the PCB around the mounting screw hole closest to the CIS does not have solder mask on the back side. This technique provides electrical grounding of the PCB to the chassis and is critical for proper operation of the scanner. This position needs to use the screw with the external star washer to insure proper electrical connection.
