# **TellerScan™ 240**

## **Countertop Check Scanner**

# **Service Manual**

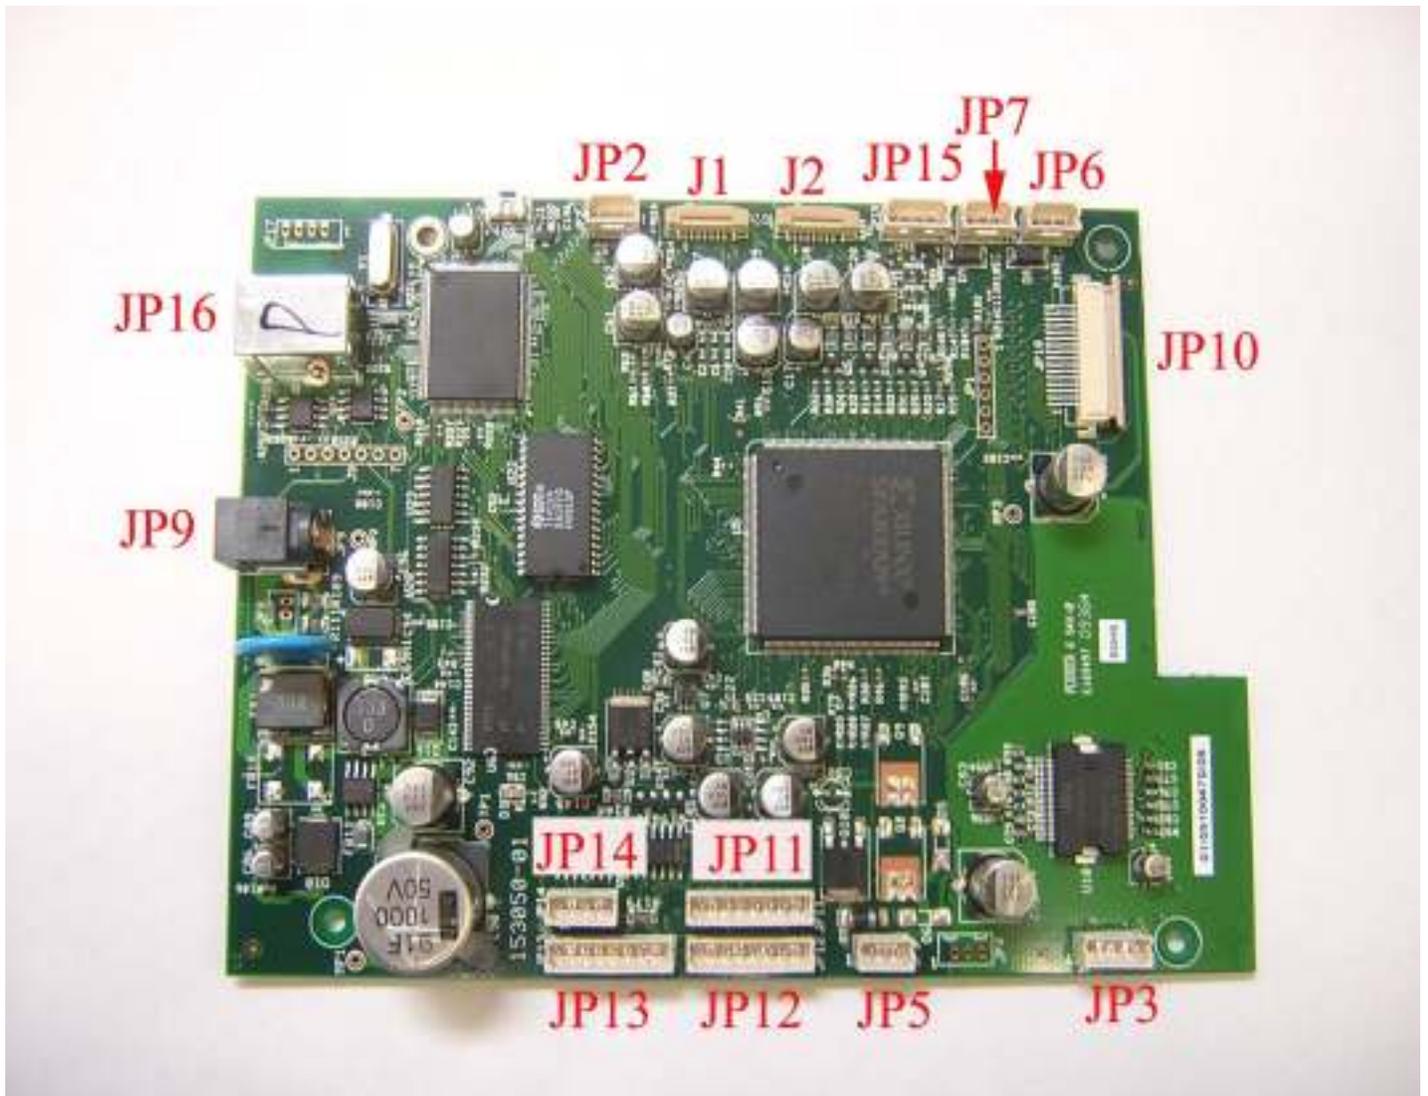
### TS240 Main CPU Board

These connectors are referenced throughout the Part Removal Section of this Service Manual.

To remove the Solenoid Assembly, first unplug the solenoid connector from the main board at position JP6 (see connector location illustration in Section 8 of this manual).
